**AIRCRAFT ACCIDENT REPORT
92-11**

EL AL FLIGHT 1862

**BOEING 747-258F 4X-AXG
BIJLMERMEER, AMSTERDAM
OCTOBER 4, 1992**

FINAL RAPPORT

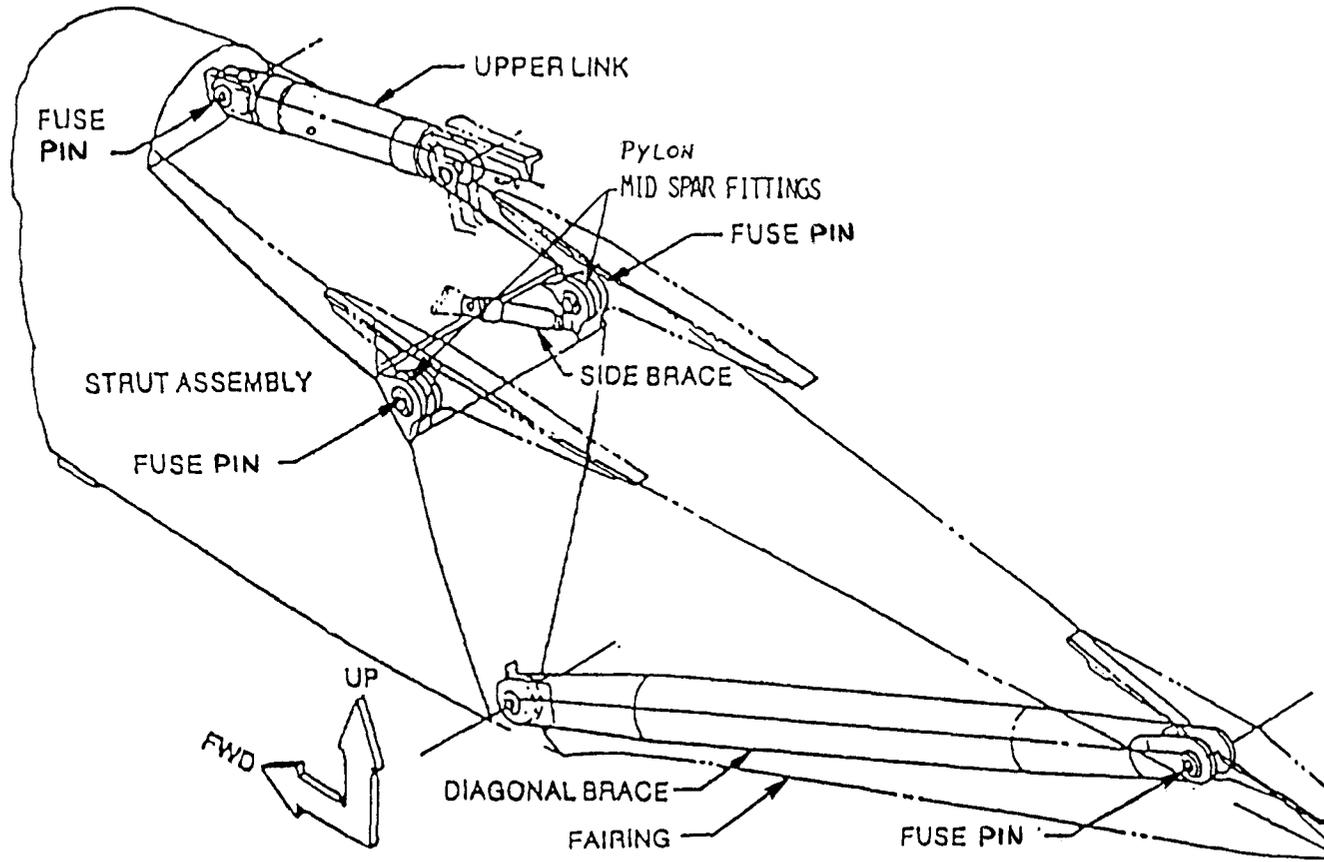
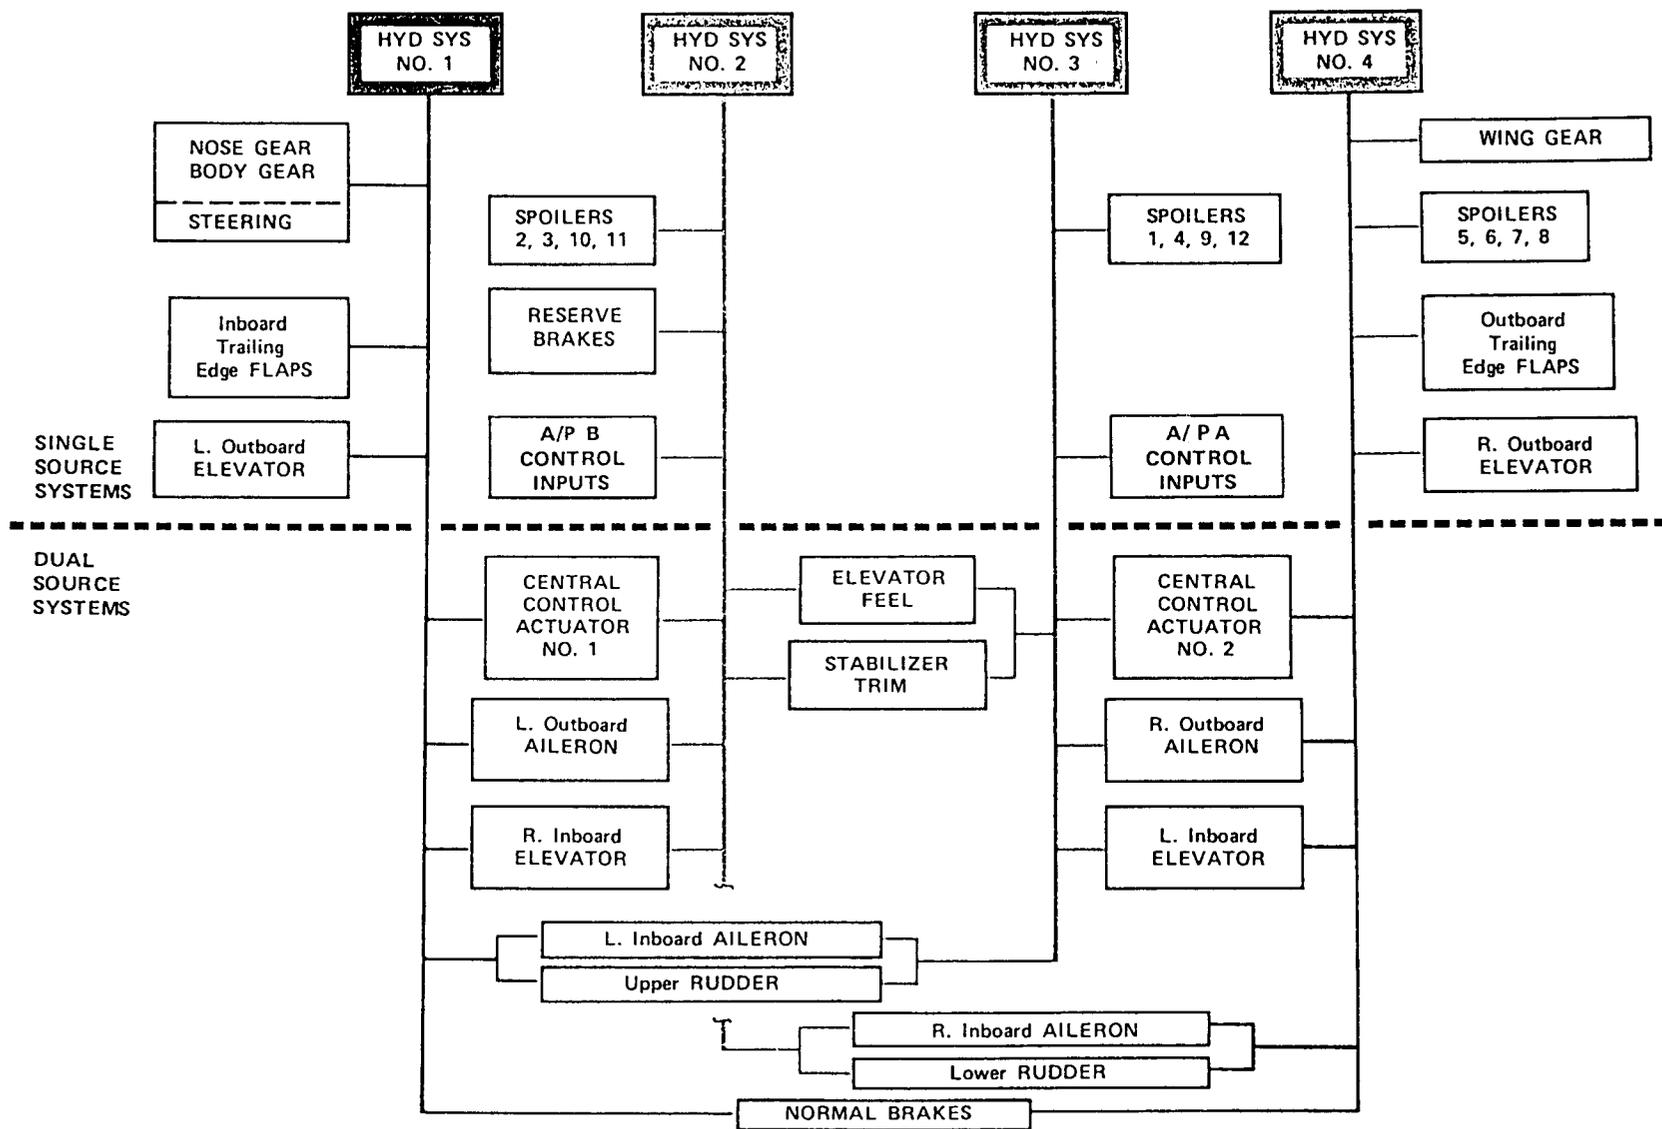
Figure 1. PYLON TO WING ATTACHMENTS RH WING

The design of the engine nacelle and pylon incorporates provisions that preclude a wing fuel cell rupture in case of engine separation, by means of structural fuses. A clean breakaway of the nacelle and/or pylon from the wing is ensured when the shearloading of the fuse pins exceeds the design load conditions.

The structural fuse concept utilizes hollow shear pins at the four wing attachment fittings between pylon and wing. The wing support structure and fittings have been designed sufficiently stronger than the fuse pins thus safeguarding the wing from structural damage in case of an overload condition.

The fuse pin at the forward end of the upper link, the aft end of the diagonal brace and at both midspar fittings are the primary fuse pins. The fuse pins at the forward end of the upper link and the aft end of the diagonal brace are designed to fail at a slightly lower load than the fuse pins at the other ends in order to assure a controlled separation of the pylon from the wing.

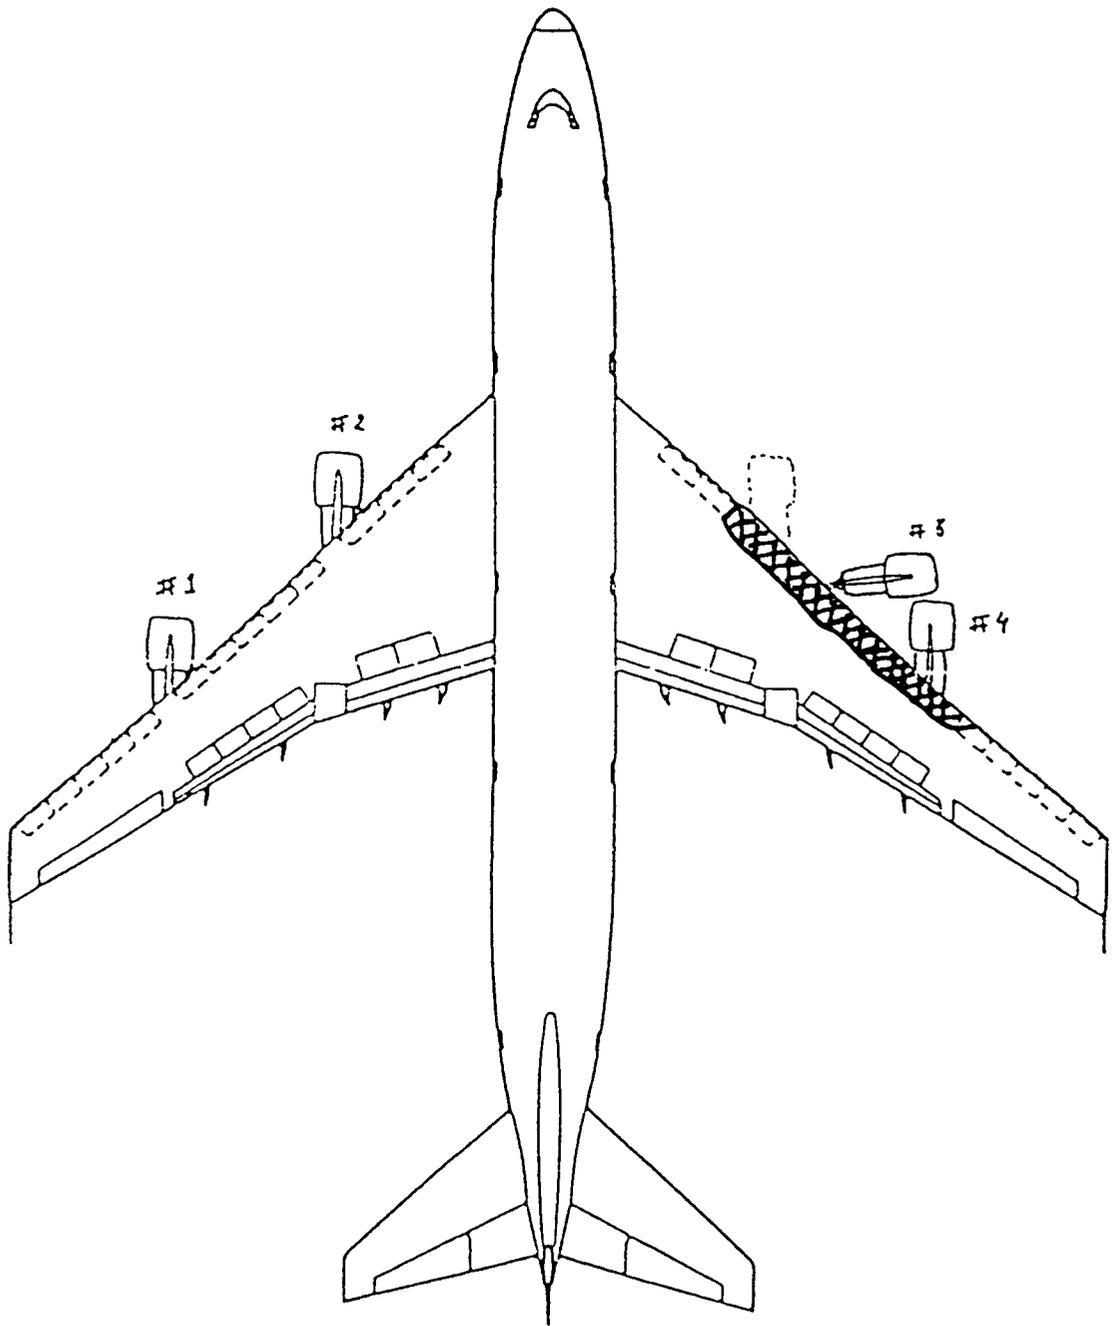
Figure 4. ESTIMATED DAMAGE TO RH WING LEADING EDGE

Engine and pylon no. 3 separated from the wing and collided with engine no. 4, in an outward and rearward direction. In view of the amount of LE flaps and LE structure found, the right wing leading edge must have been damaged up to the front spar of the right hand wing over an area approximately 1 meter left of pylon no. 3 to approx 1 meter right of no. 4. It is assumed that due to the speed of the aircraft, the aerodynamic distortion and turbulence, some parts were blown off the leading edge of the right hand wing up to the front spar.

Figure 4 illustrates the estimated damage to the right hand wing.

*Note:*The amount of damage on the left wing leading edge after separation of pylon no. 2, from a B747 accident at Anchorage on March 31, 1993, is indicative for the amount of damage probably inflicted on the EI AI 1862 right wing leading edge.

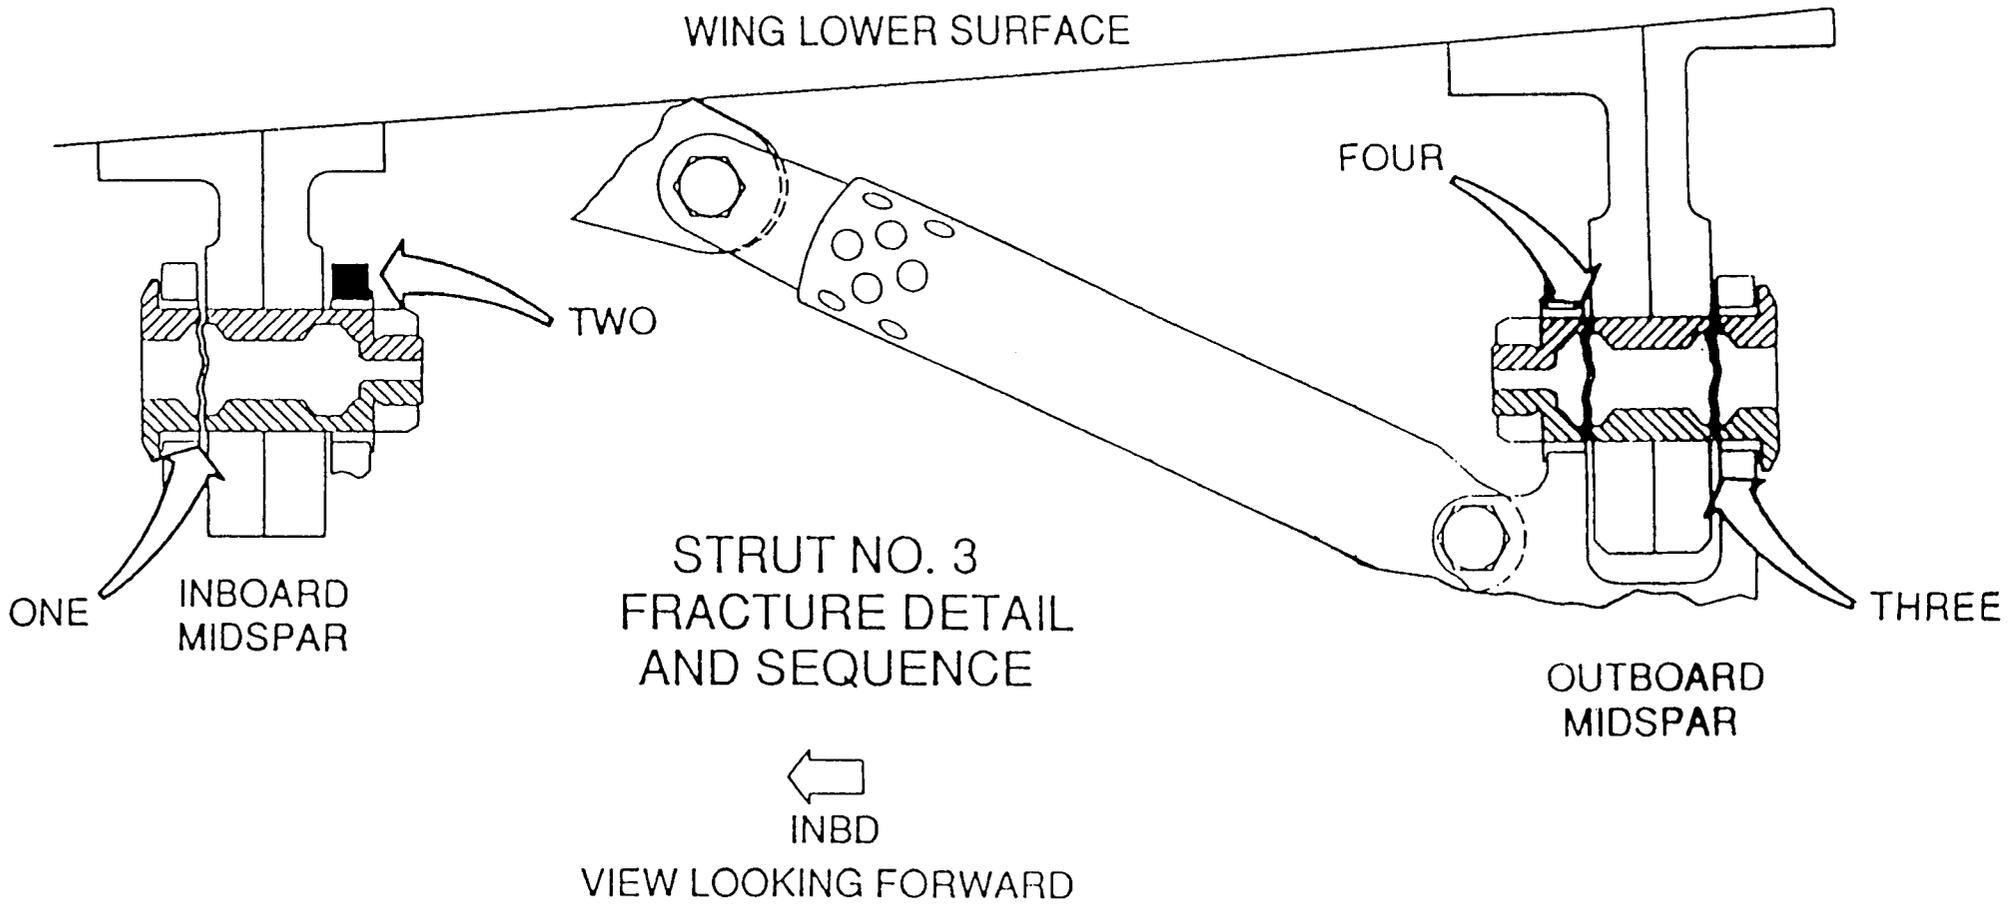
Figure 6. PROBABLE SEPARATION SEQUENCE

The inboard midspar fitting was recovered. The outboard lug of the fitting had fractured with a 150 degrees segment of the lug missing. The lug fracture was determined to be ductile (i.e. no fatigue) and appeared to have resulted primarily from tension and to a lesser extent from lateral bending. The ductile failure can only be explained if it was eccentrically loaded. For this to occur the inboard shear face of the fuse pin must have sheared first in order to subject the lug to an eccentric load.

As there is no in service evidence that the EI Al airplane experienced a static overload preceding the accident it is assumed that the inboard shear face of the fuse pin was initially fatigued and then failed under normal flight conditions.

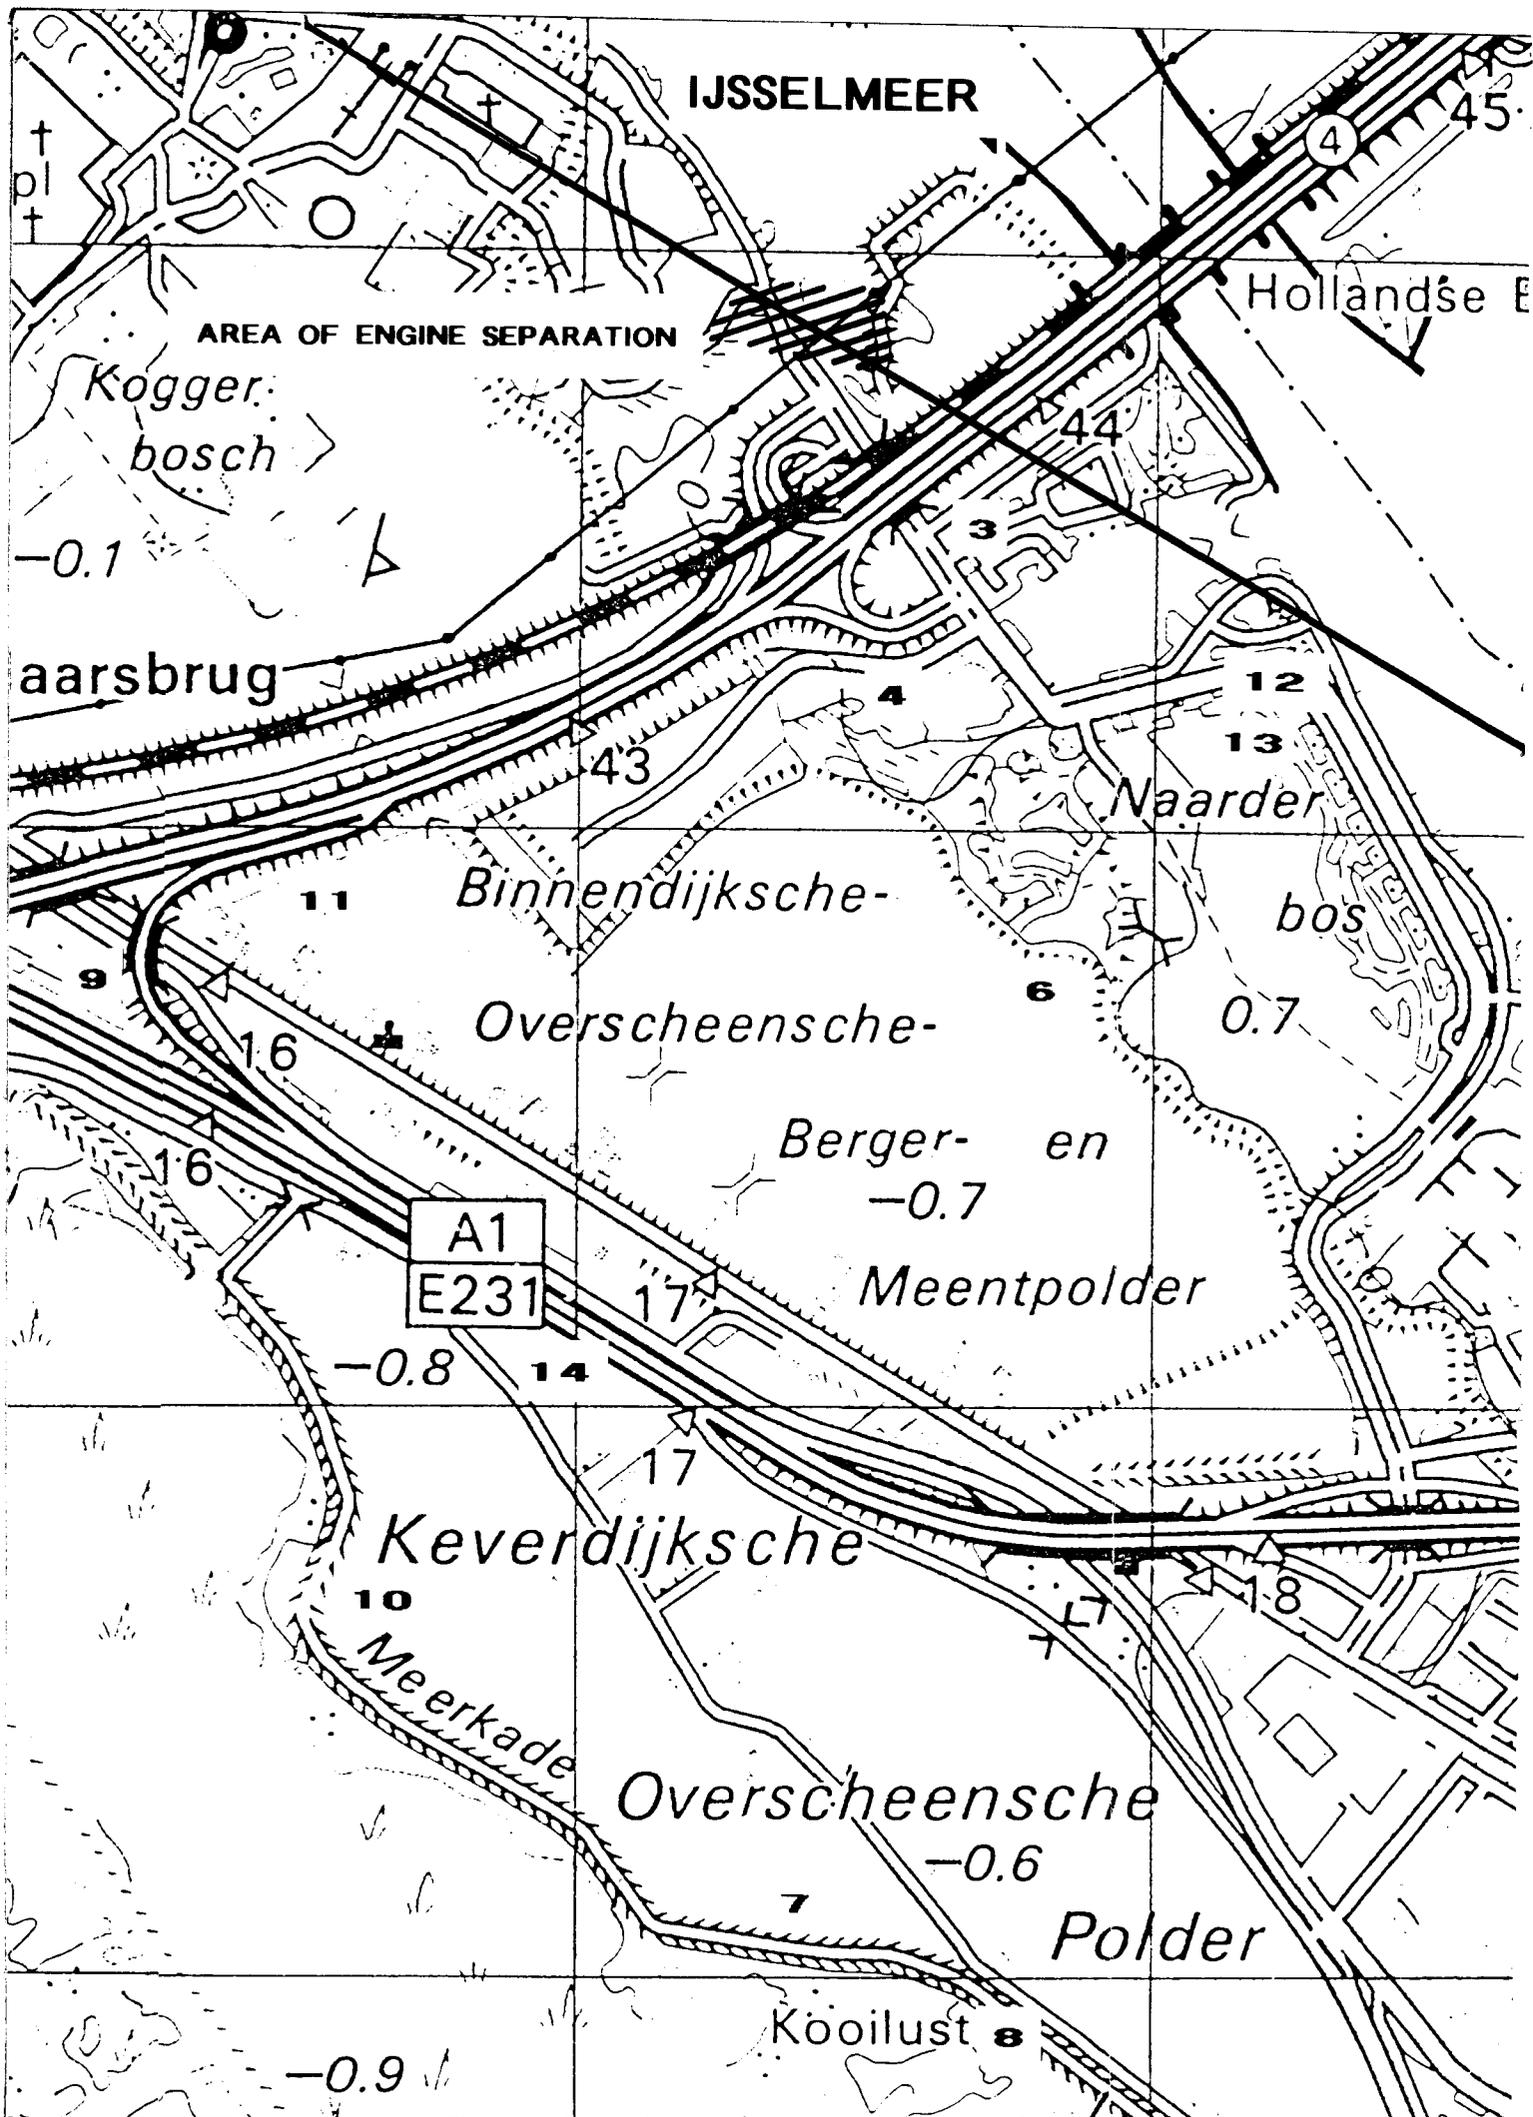
1. Engine no. 4, with pylon and cowling parts of no. 4
2. Engine no. 3, with pylon and cowling parts of no. 3 and 4, parts of fanblades of no. 4
3. Diagonal brace no. 3
4. Diagonal brace no. 4
5. Spinner no. 4
6. Part of tailcone no. 3
7. Tip of tailcone no. 3
8. Reverser screen parts
9. Cowling parts no. 3
10. Cowling parts
11. Part wing leading edge
12. Leading edge flap no. 18 (RH wing) and flapdrive
13. Air driven pump no. 3 and 4
14. Rear part of pylon no. 4
15. Pneumatic system bleed air pipe (near Muiden, not on the map)

Scattered over the area: small parts of honeycomb material of cowling no. 4 and parts of leading edge panels and structure of the RH wing

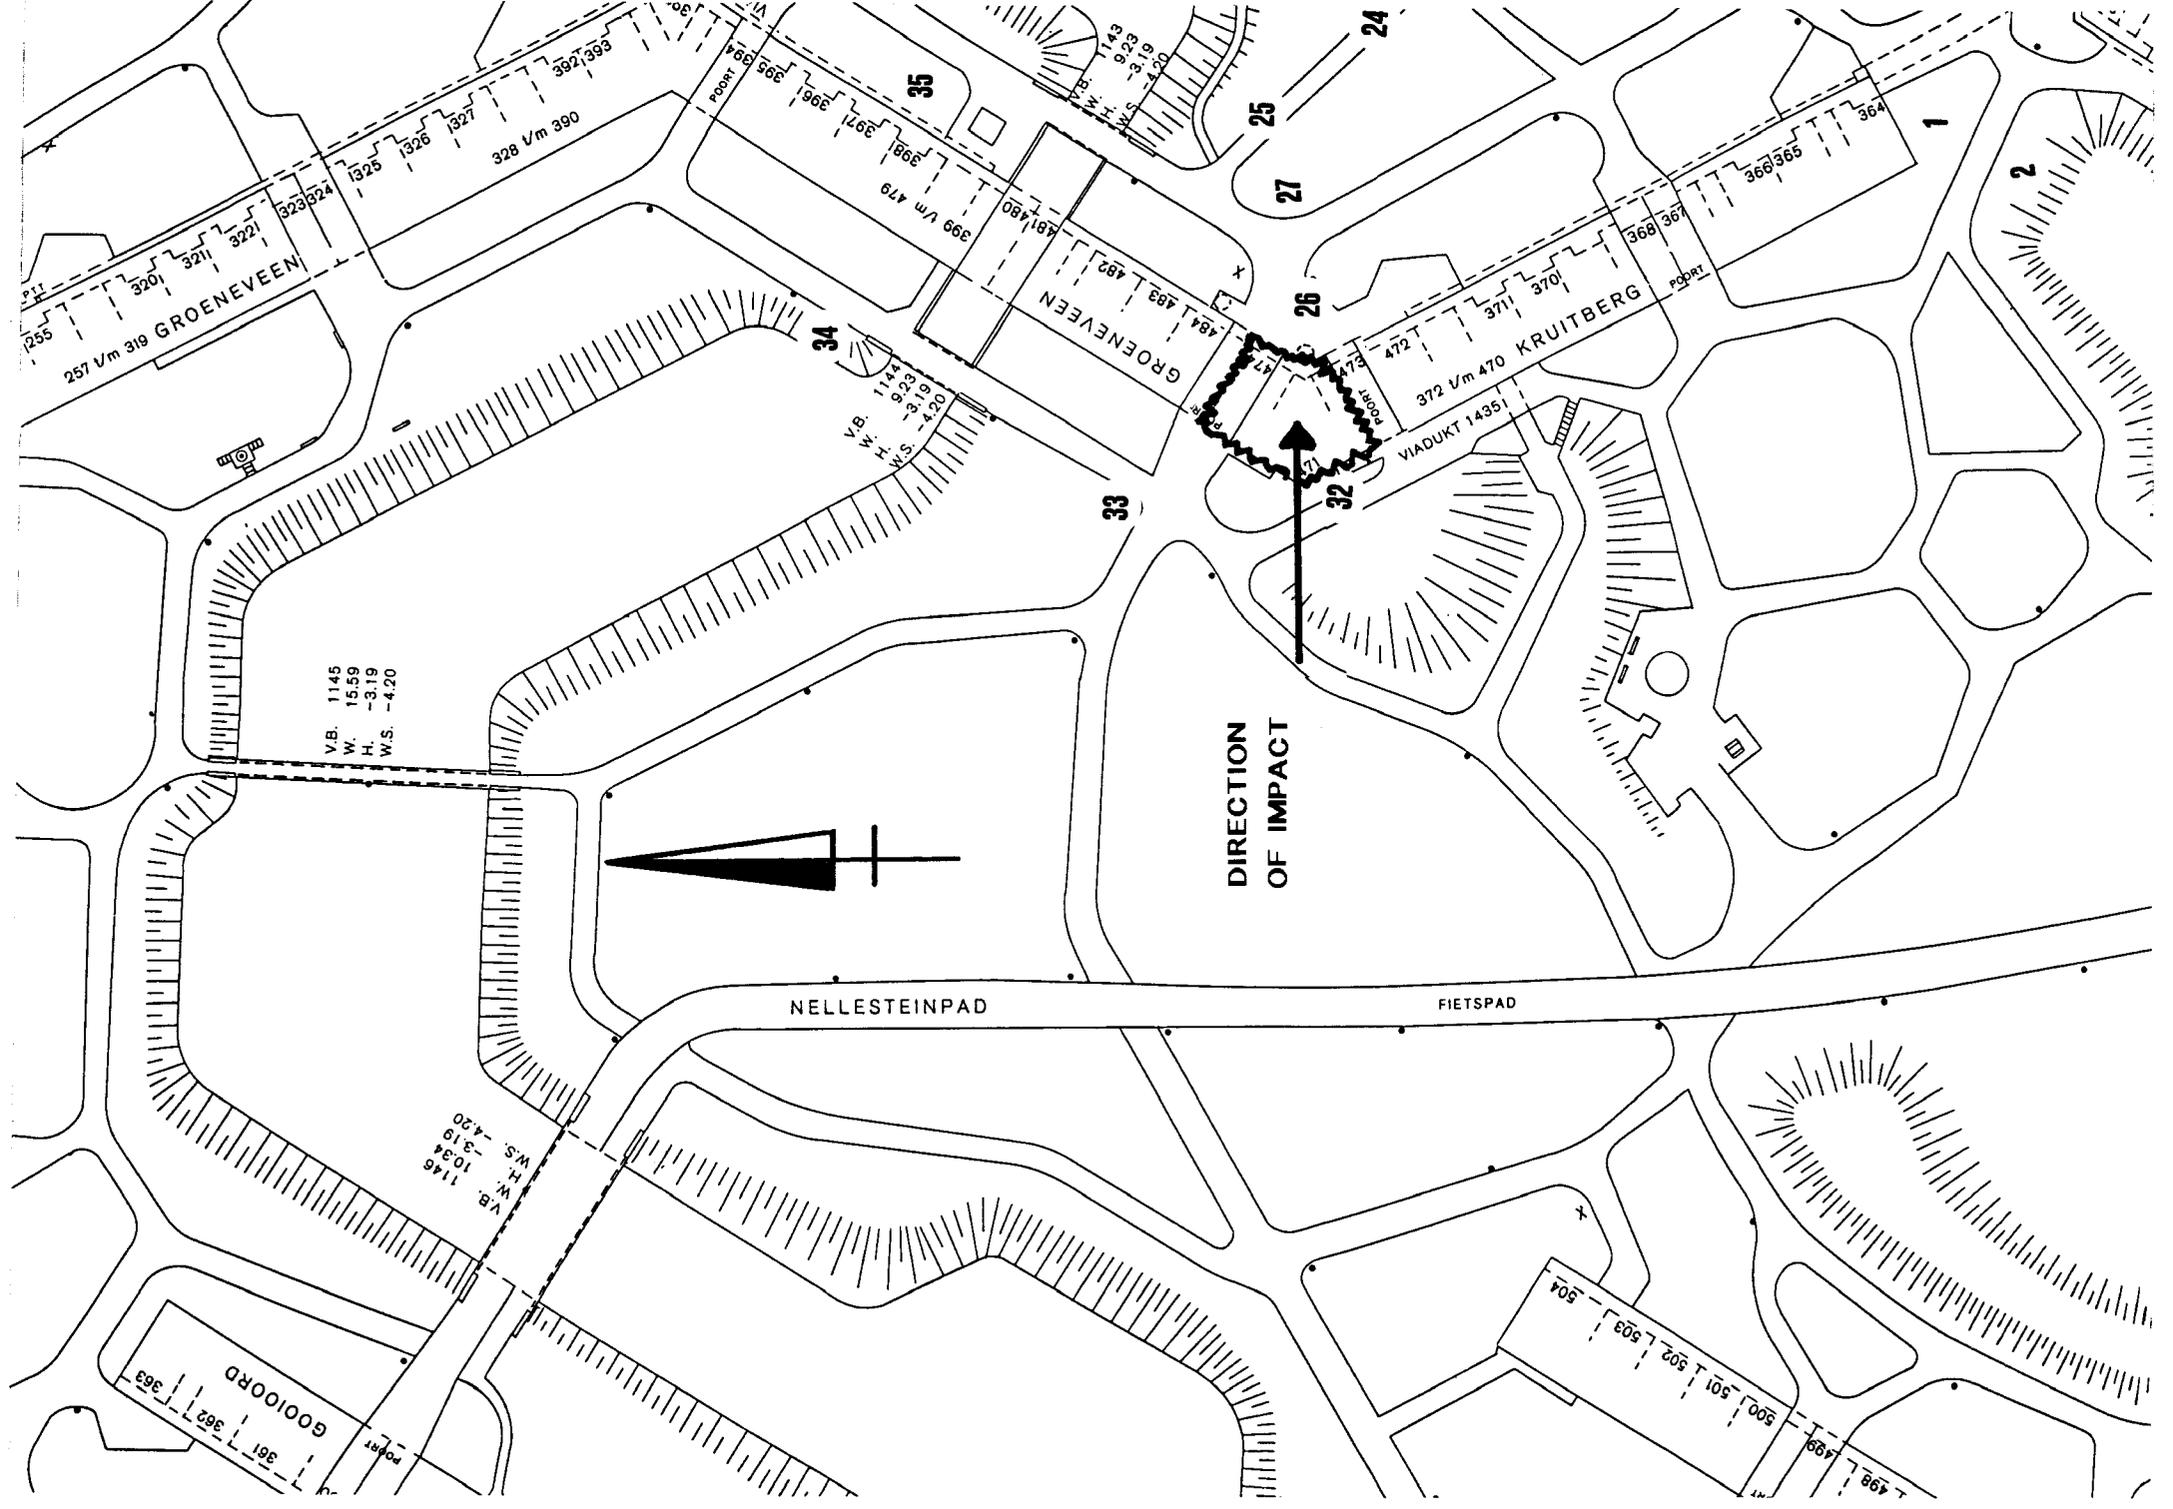
27. Parts maingear (wing and body)
Wing centersection
28. Engine cowling
29. Main gear door
30. Part rudder

31. Pylon with engine casing
32. Parts tailsection
33. Main gear door and fuselage parts
34. Parts R.H. wing
35. Parts L.H. wing, parts fin and stabilizer
