Failure Analysis Engine/Pylon Separation EL AL B-747

C.W. van Santen,
RLD

Summary

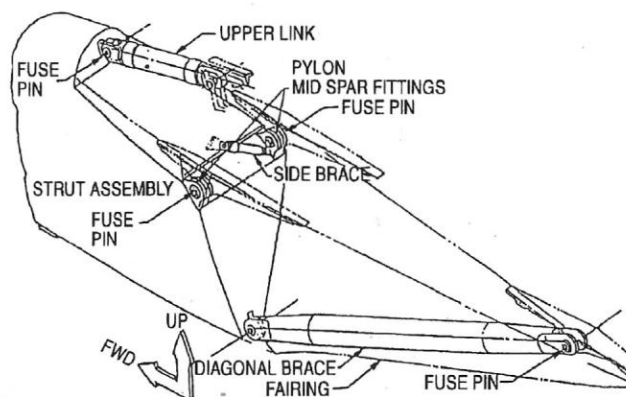
Fig. 1 Pylon to wing attachments RH wing

It is therefore concluded that the separation of the engine pylon was caused by a failure of connecting components that attach the pylon to the wing of the airplane (see Fig. 1).

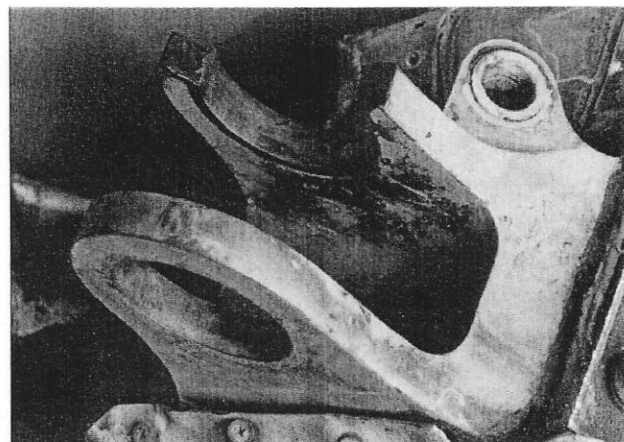
Fig. 2 Inboard midspar fitting

The inboard midspar fitting was recovered. The outboard lug of the fitting had fractured with a 150 degrees segment of the lug missing. The lug fracture was determined to be ductile (i.e. no fatigue) and appeared to have resulted primarily from tension and to a lesser extent from lateral bending (see Fig. 2). The ductile failure can only be explained if it was excentrically loaded. For this to occur the inboard shear face of the fuse pin must have sheared first in order to subject the lug to an excentric load.

As there is no in service evidence that the El Al airplane experienced a static overload preceding the accident it is assumed that the inboard shear face of the fuse pin was initially fatigued and then failed under normal flight conditions.

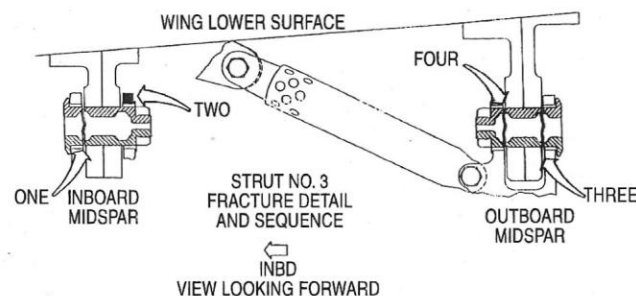
Fig. 3 Probable separation sequence

Therefore the scenario which is most likely, is (1) a fracture initiated by a fatigue crack of the shear face of the inboard midspar fuse pin. This was followed by (2) sequential failure of the outboard lug of the inboard midspar fitting. Then (3) the outboard shear face. Finally (4) the inboard shear face of the outboard midspar fuse pin (see Fig. 3 and 4). The subsequent engine/pylon separation occurred during the flight out of Schiphol Airport at 6500 feet altitude and at an IAS of 267 knots.
