NLR-TP-2003-392

Flight data reconstruction and simulation of the 1992 Amsterdam Bijlmermeer airplane accident

M.H. Smaili

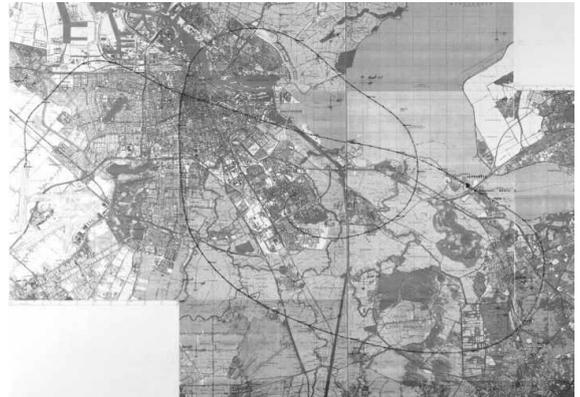
Fig.3: Flight path of the accident aircraft

At 17:31.17, the crew indicated that they needed “12 miles final for landing”. During the transmission of this reply, the crew commenced the selection of flaps 1 for landing. While instructed to turn right to heading 100 the crew reported “no. 3 and 4 are out and we have problems with the flaps”. After the aircraft was established on heading 120, the crew maintained an indicated airspeed of 260 knots and a gradual descent. ATC cleared the flight for approach and instructed a heading of 270 to intercept the final approach course. Indicated airspeed remained at 260 knots at an altitude of 4,000 feet. After the heading instruction from ATC, it took about thirty seconds before the heading change was actually performed. When it became clear that the aircraft was going to overshoot the runway centerline, ATC instructed the flight to turn further to heading 290 to intercept the localizer from the south. Twenty seconds later a new heading of 310 was instructed by ATC, along with the clearance to descent to 1,500 feet.

At 17:35.03, the crew acknowledged the clearance by reporting “...1500... and we have a controlling problem...”. At this point, indicated airspeed decreased to 256 knots. The crew was losing flight control and approximately 25 seconds later the captain called, “going down 1862, going down...”. During this transmission, the crew was trying to recover the aircraft by raising the flaps and by lowering the gear. The stick shaker and ground proximity warning system were audible in the background of the transmission. The remaining engines no. 1 and 2 were set at maximum thrust.

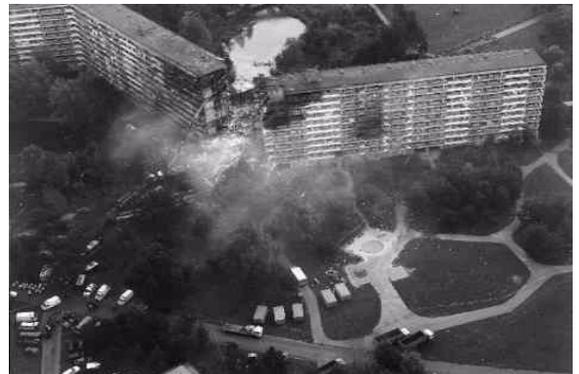
Fig. 4: Impact area of the accident aircraft

At 17:35.42, the aircraft impacted at a roll angle of approximately 104° , a load factor of about $2.5\text{ g}'\text{s}$ and approximately 70° pitch down.

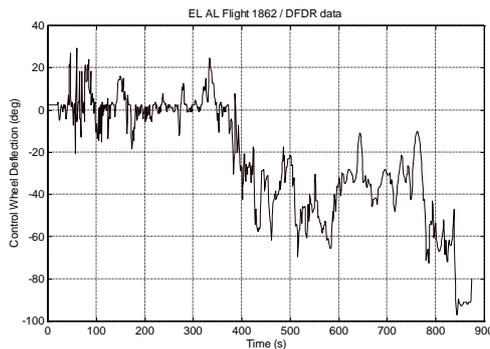
Fig. 5: DFDR control wheel deflections

In general, the DFDR indicates that both pedal and control wheel were used for turn initiation and roll control. The first turn after the separation of the engines no. 3 and 4 is performed at almost zero pedal deflection. At final control loss, control wheel deflection is maximum while rudder pedal deflection is less than maximum. An analysis of the flight in a flight simulator² indicated that in the above mentioned conditions and with maximum rudder pedal input, approximately 30 degrees left control wheel

deflection was needed to maintain straight flight. This condition was simulated with trailing edge flaps up. According to the hydraulic system architecture, this condition locks the outboard ailerons when outboard flaps are not selected. For the case of the accident flight, the additional wing damage and degraded effectiveness of the right wing inboard aileron required larger left wing down control wheel deflections than in the nominal case. This effect can be determined from the DFDR and was confirmed by reconstruction of the flight.

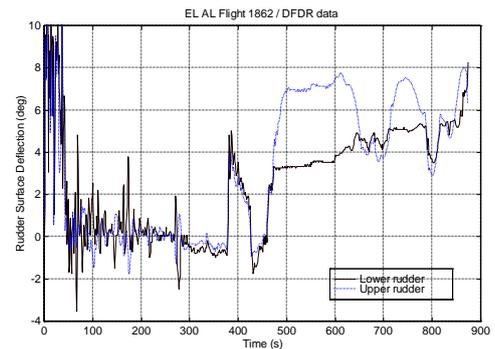
Fig. 6: DFDR rudder surface deflections

According to the DFDR, maximum available rudder was needed during the straight legs to counteract the yawing moment. The traces of the rudder control surface activity as a response to the rudder pedal inputs can be seen in figure 6. In this figure, a limited control authority of the lower rudder is visible. From the DFDR it can be determined that lagging of the lower rudder started after the first turn, approximately 100 seconds after engine separation and at full left pedal (engine separation occurring at $t=378$ s). Pedal relaxation during turn initiations caused the lower rudder to follow the upper rudder again. At final loss of control and increasing roll angle, the DFDR shows a sudden increase of lower rudder deflection while the upper rudder stays behind at a smaller deflection.

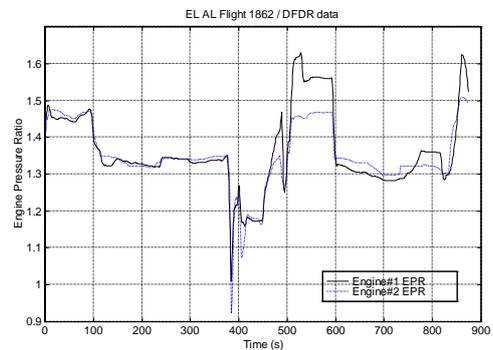
Fig. 7: DFDR engine no. 1 and 2 thrust settings

The DFDR indicates (figure 7) that the controllability and performance condition after engine separation required engine no. 1 and 2 thrust settings between approximately MCT (EPR 1.3) and overboost thrust (EPR 1.62). High thrust (EPR#1 1.56/ EPR#2 1.45) is needed to sustain almost straight and level flight. This condition is reached approximately 120 seconds after separation of the engines and after completion of the first turn towards a heading north.

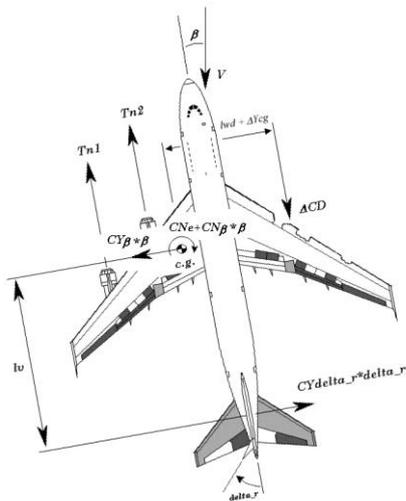
Fig. 8: Straight and stationary flight with right wing engine separation at zero roll angle

Figure 8 illustrates the aircraft condition for stationary and straight flight at zero roll angle under the conditions of the accident aircraft. In wings level flight a positive sideslip angle is required for straight flight to compensate the lateral force in the vertical tailplane. This condition decreases the available performance of the aircraft due to the additional drag of the sideslip. However, more lateral control margin is created due to the contribution of the increasing negative rolling moment due to sideslip.

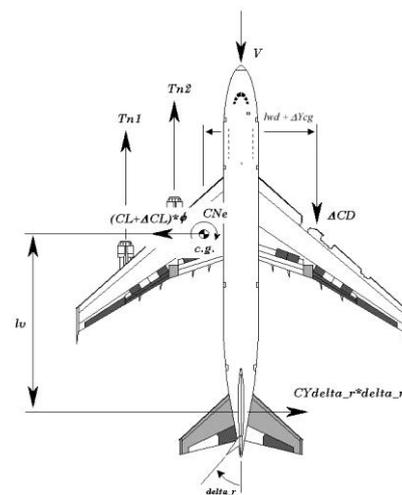
Fig. 9: Straight and stationary flight with right wing engine separation at zero sideslip angle

Straight and stationary flight at zero sideslip angle with a separation of the right wing engines is illustrated in figure 9. This condition actually improves the available performance of the aircraft as the zero sideslip reduces drag. In addition, the required directional control is less demanding to sustain the flight condition. Lateral control margin is, however, reduced as no positive sideslip is available.

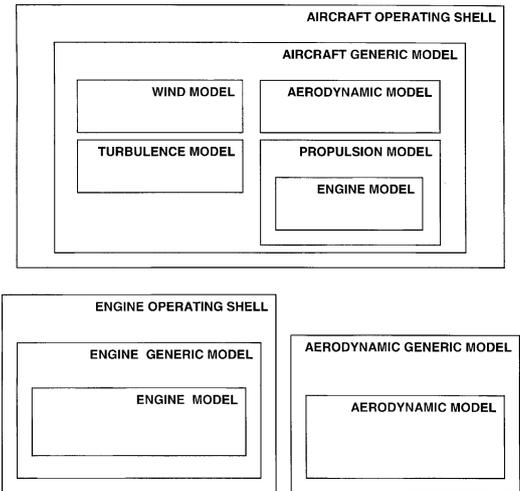
Fig. 10: Model architecture of the simulation environment

The simulation environment incorporates a nonlinear aerodynamic model and a flight control system model, reflecting the hydraulic system architecture, of the accident aircraft. The modeled control surfaces were subjected to aerodynamic effects throughout the flight envelope. The environment is operated from its own operating shell. On-line simulations of the reconstructed model can be performed interactively or system failures can be selected that affect the aircraft's flight mechanics. For the accident analysis, the simulation environment was extended to simulate separation of the right wing engines, incorporating all its associated system failures, and provided the capability to import DFDR pilot control inputs. In this setup, the reconstructed flight data was visualised in addition to any desired flight parameter that was not recorded by the DFDR. To account for the effect of the right wing damage, the aerodynamic model was extended with an estimate of the aerodynamic effects following the separation of the engines.

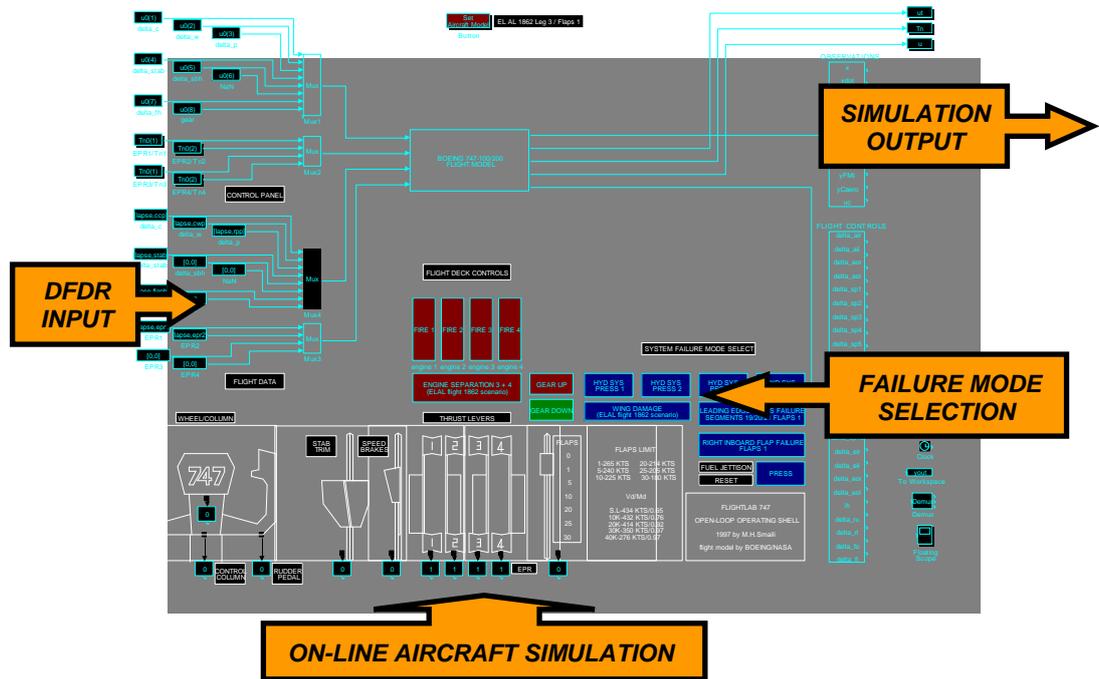
Fig. 11: Simulation environment for flight data reconstruction and analysis

For the accident analysis, the simulation software was given the capability to reconstruct the DFDR data and to perform failure mode and effect analysis. The operating shell of the software (figure 11) offers several interactive capabilities for on-line simulations of the reconstructed model and analysis of the flight control system. The user may select a desired flight condition or specific failure mode scenario. Simulation results may then be recorded and used in conjunction with the analysis tools from DASMAT. This may, for instance, include the generation of a linearised model for flight control design applications. The operating shell offers the following capabilities for DFDR reconstruction and analysis of the reconstructed model:

- Import of DFDR data
- On-line simulation of aircraft, flight control and hydraulic systems
- Selection of aircraft failure modes, including:
 - Engine separation
 - Hydraulic system failures
- Visualisation of reconstructed flight data
- Visualisation of reconstructed flight control surface deflections
- 3D visualisation of reconstructed flight profile

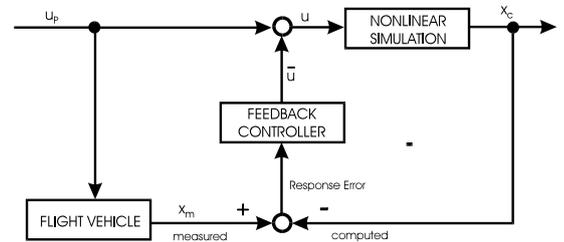
Fig. 12: Inverse simulation principle for flight data reconstruction

The reconstruction is based on a model validation method using inverse simulation¹² (figure 12). The DFDR pilot control inputs u_p are directly applied to the simulation model of the aircraft and the flight control system. The response error of the simulation output x_c and measured DFDR data x_m are input to a feedback controller. The output of the feedback controller is a measure for the fidelity of the reconstructed model. The reconstruction method has the advantage that the combined effect of structural and flight control system failures may be visualised using the simulation inputs and outputs. The estimation of the aerodynamic effects due to engine separation can be

performed by adjusting the parameters of a model structure of the damaged wing until the controller output is minimised. An additional advantage of the method is that the DFDR data, with a low sample rate, can be used directly to excite the simulation model. The reconstruction setup for the analysis is illustrated in figure 13. A proportional feedback controller using pitch and roll data proved to be sufficient to obtain a reasonable match with measurements and simulation data.

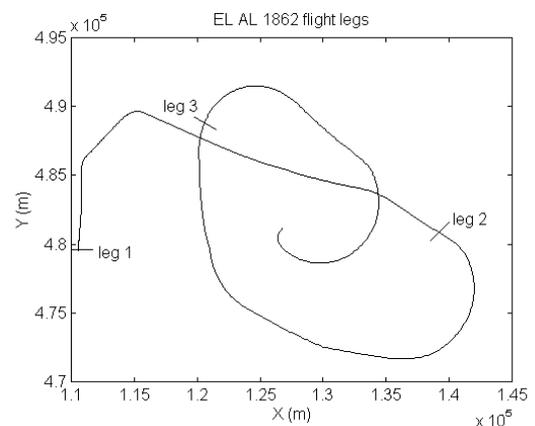
Fig. 14: Flight legs for DFDR reconstruction

This subdivision was based on the following considerations:

- Validation of the simulation model and reconstruction method without failure modes
- Estimation of aerodynamic effects for different aircraft configurations
- Reduction of computational load

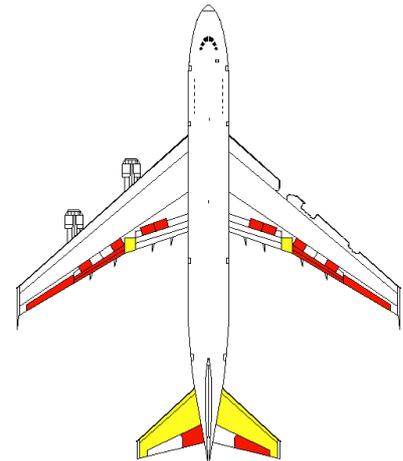
Fig. 15: Failure modes and damage configuration of the accident aircraft

The aircraft failure mode configuration after the separation of the right wing engines (figure 15) was included in the simulation and consisted of:

- Lift loss due to wing damage, ΔC_{Lsep}
- Rolling moment due to wing damage, ΔC_{lsep}
- Drag due to wing damage, ΔC_{Dsep}
- Yawing moment due to wing damage, ΔC_{nsep}
- Pitching moment due to wing damage, ΔC_{msep}
- Right inboard aileron and spoiler 10 and 11 aerodynamic efficiency loss

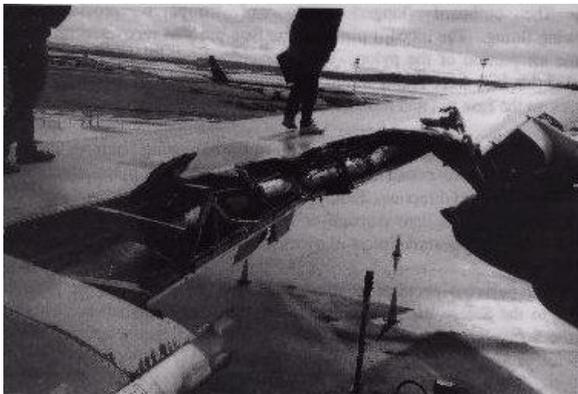
Fig. 16: Wing damage due to separation of engine no.2, Boeing 747, March 31, 1993 (source: ref. [13])

On March 31, 1993, a Boeing 747 freighter encountered a separation of the no. 2 engine under turbulence conditions¹³. Despite the severe performance and controllability problems caused by the separated engine, the flight crew managed to recover the aircraft by means of an emergency landing. The flight conditions after engine separation required up to full right rudder pedal, approximately 60 degrees of right wing down control wheel deflection and overboost thrust on the no. 1 engine. The structural damage to the left wing of the aircraft (figure 16) may have been representative for the amount of structural damage incurred by the aircraft of the Bijlmermeer accident.

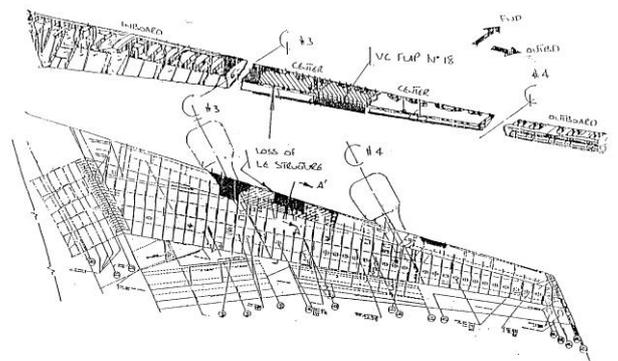
Fig. 17: Estimated right wing damage of the Amsterdam Bijlmermeer accident aircraft

will further increase resulting into a reduction of controllability and performance. Figure 17 depicts an estimate of the right wing damage of the Amsterdam Bijlmermeer accident aircraft after the separation of the engines. The figure indicates that most damage of the right wing was located near the no. 3 engine. This may have caused a degradation of the aerodynamic efficiency of the inboard aileron located behind the damage. Additionally, the reconstruction method enabled to identify a significant pitch down moment effect after the separation of the engines. It is difficult to determine the individual contributions to this effect, as the exact damage to the right wing is not known. The effect was most probably caused by a combination of a change of induced downwash near the stabilizer, wing leading edge damage, effect of the engines and effect of selected flaps. An estimate of the additional pitch down moment was required to obtain a reasonable match with the DFDR data.

Based on the estimates of damage to the right wing, a model structure of the aerodynamic effects due to engine separation was included in the simulation model for the reconstruction³. The aerodynamic estimates in the model, obtained during an extensive tuning process, resulted into a reasonable match with the performance and control capabilities of the accident aircraft. However, it should be emphasised that the aerodynamic effects due to structural failure, as characteristic for the accident flight, are very complex and difficult to determine precisely. This is especially true due to the fact that the actual amount of structural damage to the right wing was unknown. Therefore, the objective for the analysis was to obtain a physically representative model of the effect of engine separation on the aircraft flight mechanics by closely matching the characteristic trends in aircraft performance and controllability as provided by the flight data recorder.

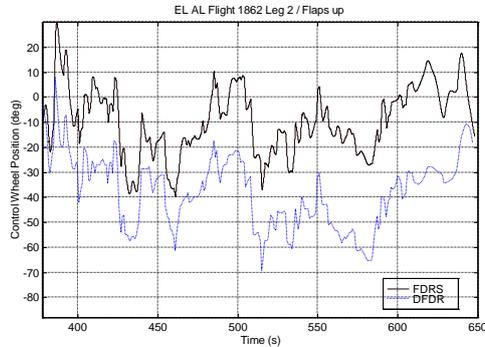
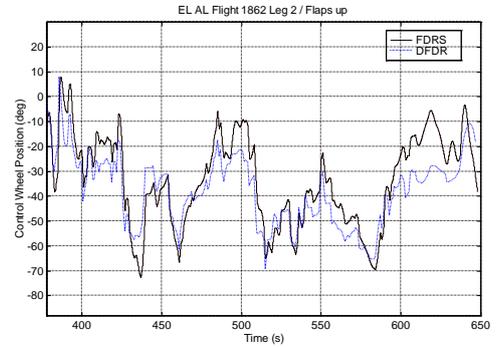
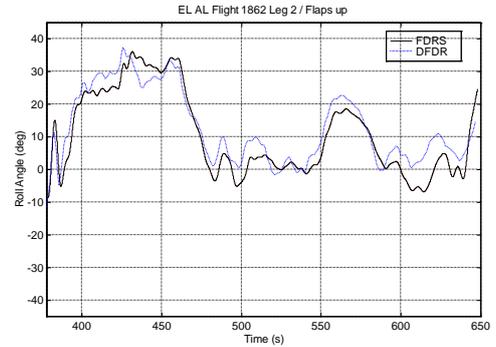
Figures 18-21 illustrate the effect of the aerodynamic estimates for the right wing damage contribution on the model input and output for $t=378-647$ s. It can be seen that, under the

prevailing flight condition, a reasonable match between DFDR and simulation for control wheel deflection (figures 18 and 19) and roll angle (figures 20 and 21) can be achieved.

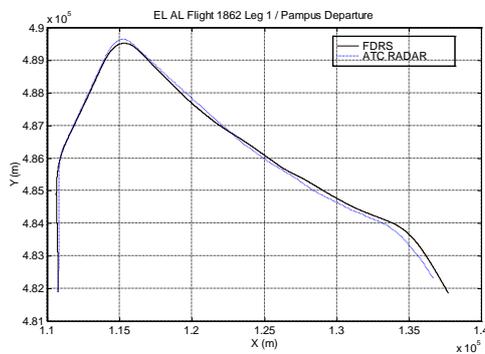
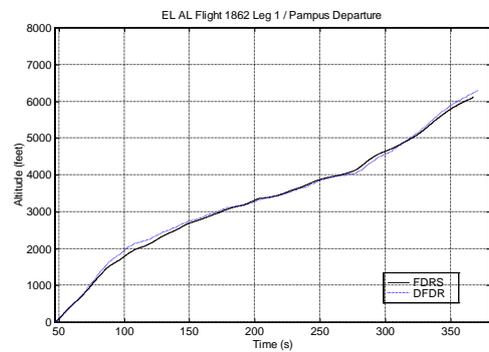
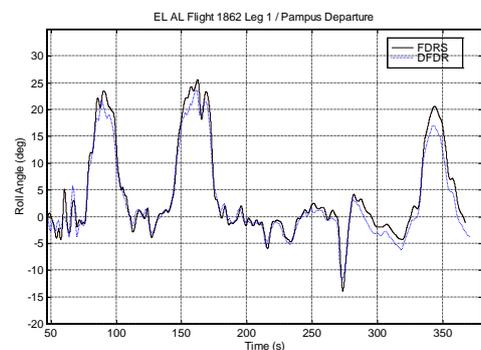
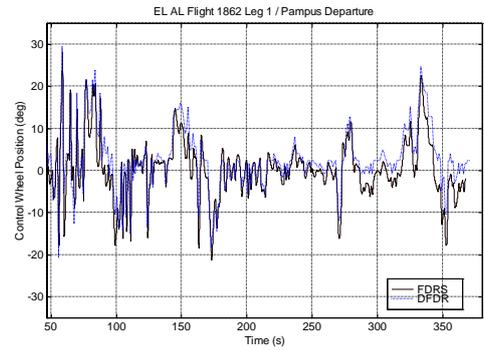
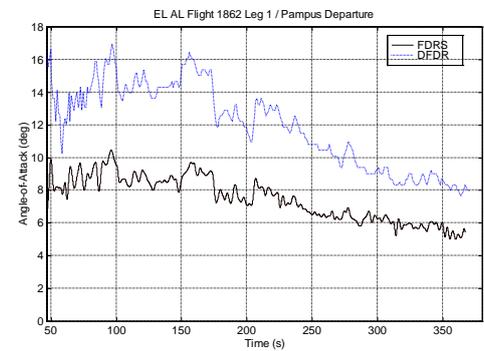
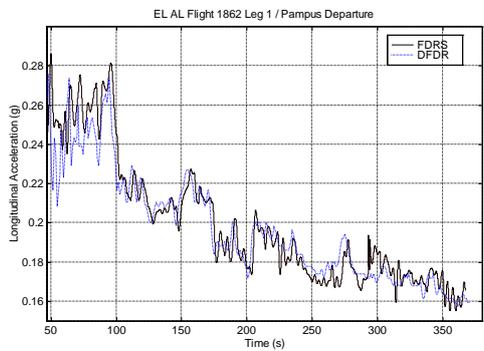
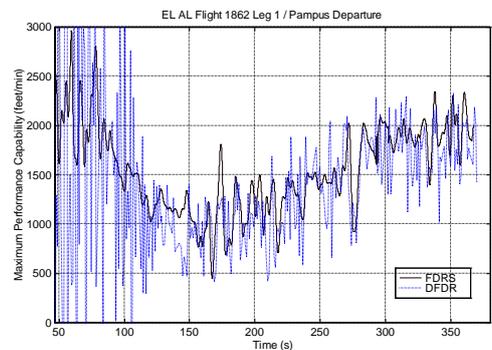
Figures 22-35 illustrate the reconstruction results of the departure and climbout of the accident aircraft up to separation of the engines. The reconstructed data matches well with the DFDR data under the prevailing meteorological conditions. Performance capabilities and controllability of the simulation model are representative of the aircraft without failure modes and for the applied thrust settings. Ground track data (figure 22) was obtained from radar sources as this information was not available from the DFDR. The angle of attack bias in figure 31 is caused by the difference between measured and reconstructed angle of attack (DFDR vane angle of attack vs. calculated body angle of attack).

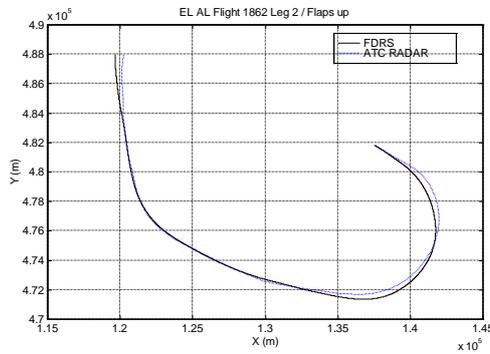
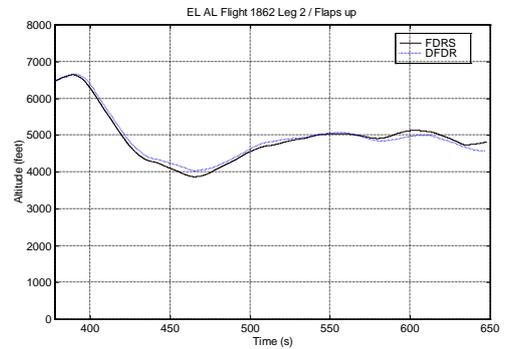
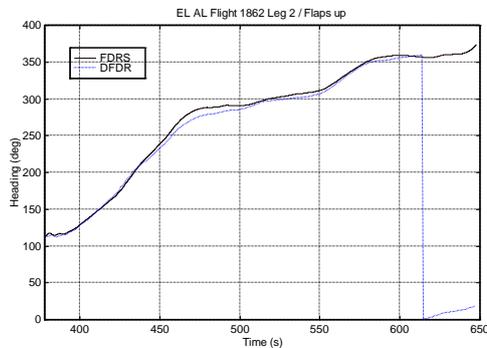
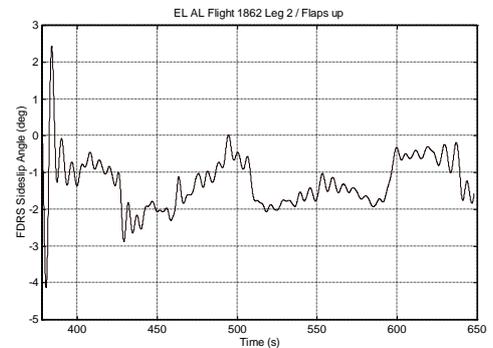
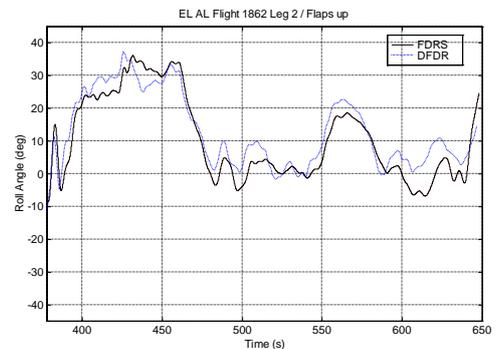
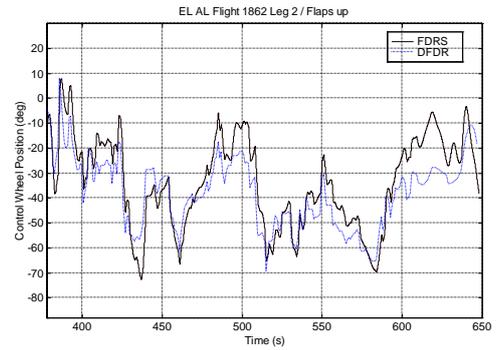
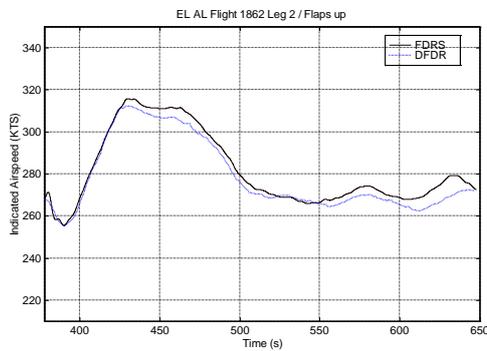
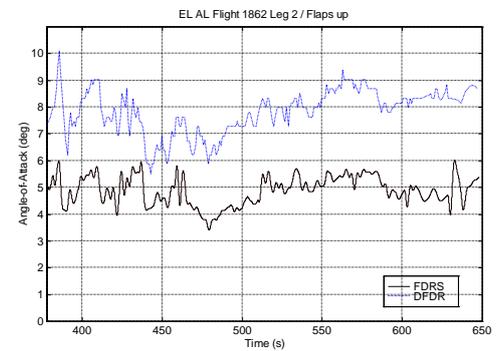
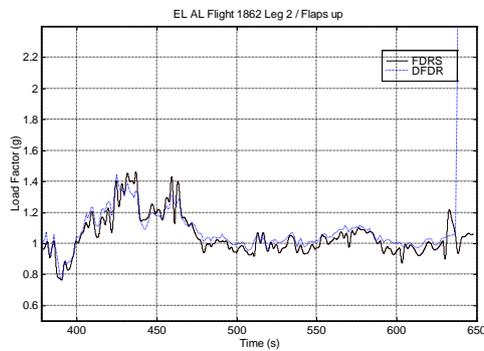
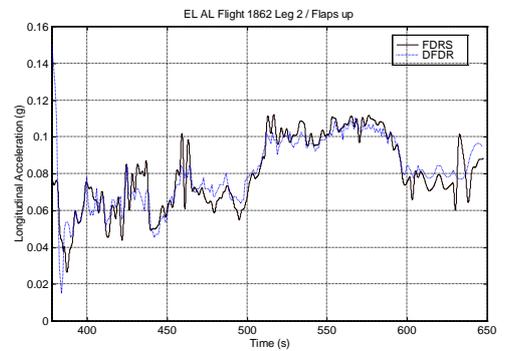
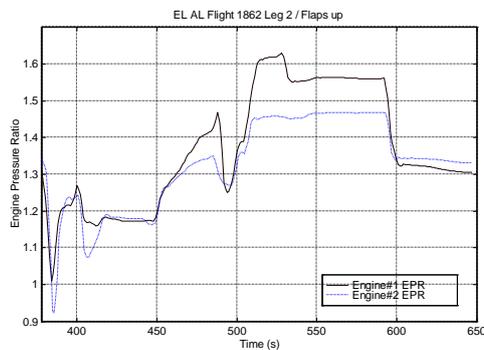
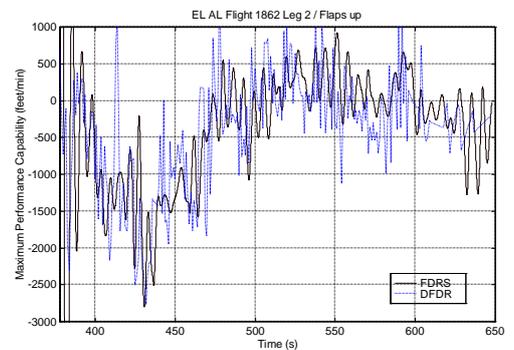
Figures 36-49 present the reconstruction results of the accident flight after separation of the engines 3 and 4 up to the selection of flaps 1. The reconstructed data matches well with the DFDR data under the prevailing meteorological conditions. Among other parameters not available from the DFDR, the reconstruction method enabled to calculate the sideslip capabilities of the accident aircraft after the separation of the engines throughout the flight stage (figure 39). The figures indicate that performance capabilities and controllability of the simulation model for this flight condition are representative of the accident aircraft with flaps up and at high thrust.

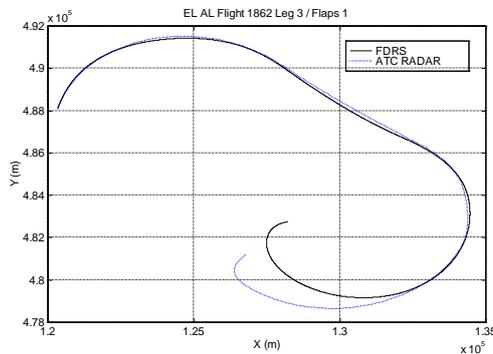
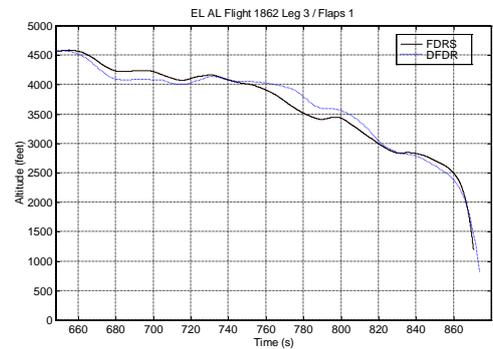
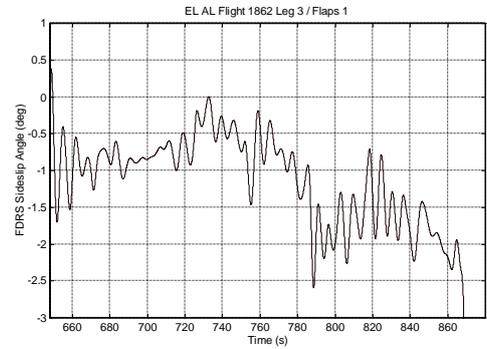
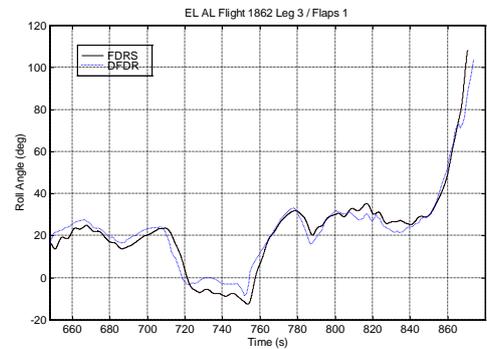
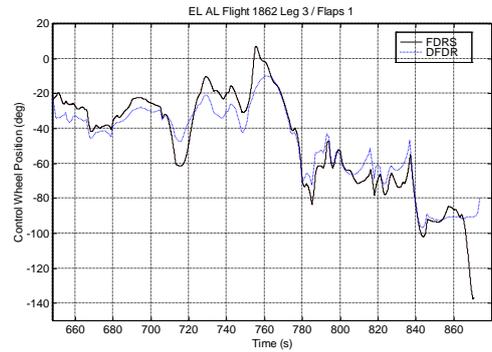
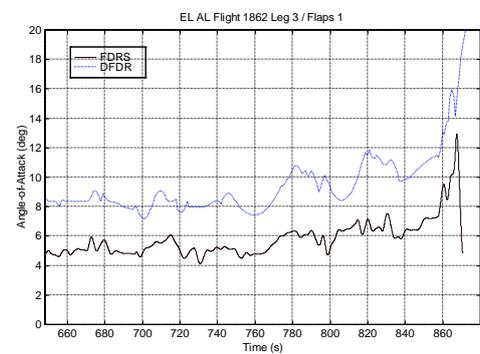
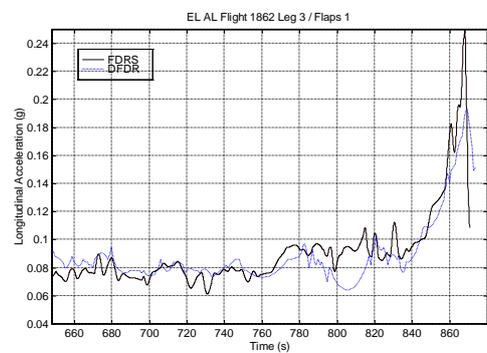
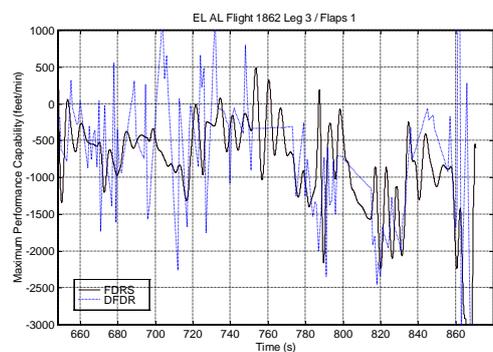
The reconstruction results of the accident flight after the selection of flaps 1 up to the final loss of control are shown in the figures 50-63. The reconstructed data shows a reasonable match with the DFDR data under the prevailing meteorological conditions. The difference between the impact area of the radar data and the simulation model (figure 50) is caused by the higher bank angle of the model from t=780 s to t=840 s and possible nonlinear effects at high angle of attack. In general, performance and control capabilities of the simulation model, up to the final stage of the flight, remain representative of the accident aircraft with inboard trailing edge flaps selected to 1 and for the applied thrust settings on the remaining engines.

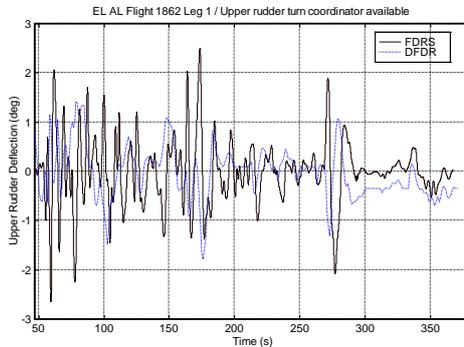
Fig. 64: Reconstructed upper rudder deflection ($t=47-371$ s)

At $t=270$ seconds, the aircraft acquires a 15 degrees roll angle to the left as a result of a control wheel input. Reconstructed upper rudder deflection is then opposite to the DFDR data. The lower rudder (figure 65) shows a reconstructed deflection consistent with the DFDR data and is opposite to the DFDR upper rudder deflection. For the upper rudder, several failure mode scenarios were applied to the simulation model. The model indicated that DFDR upper rudder activity can be reconstructed in case the upper rudder turn co-ordinator is not available (figure 66). In this condition, figures 66 and 67 indicate that at $t=270$ seconds both reconstructed upper and lower rudder deflections are consistent with the DFDR data.

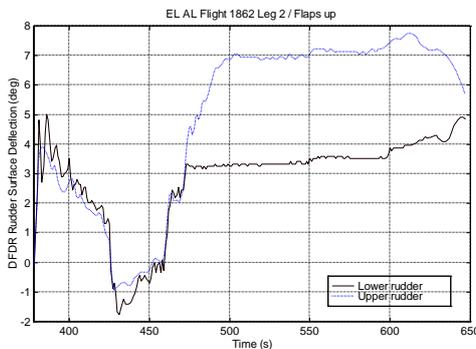
Fig. 68: DFDR upper and lower rudder deflections ($t=378-647$ s)

Upper and lower rudder activity was subsequently evaluated after the separation of the engines (figures 68-73). The DFDR indicates that lower rudder authority was limited after the engines were separated from the aircraft (figure 68). To investigate the probable cause of this anomaly, rudder deflections were reconstructed for the second and third flight leg ($t=378-874$ s). It was found that deflections of the lower rudder, as indicated on the DFDR, were related to the flight condition at some stages. A typical effect starts at $t=858$ s when the aircraft loses flight control at full rudder pedal while bank angle increases. In this condition, at $t=865$ s, lower rudder deflection increases while upper rudder is limited and decreasing (figure 70).

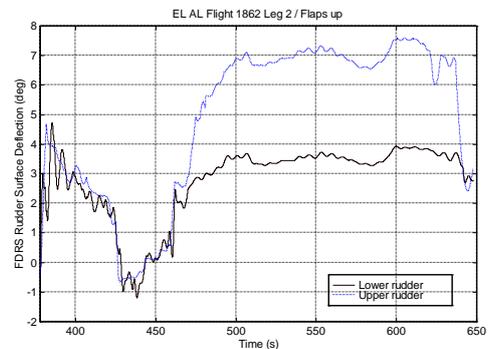
Fig. 69: Reconstructed upper and lower rudder deflections ($t=378-647$ s)

Both upper and lower rudders are equipped with a dual-tandem actuator. Loss of one actuator, due to loss of hydraulic supply, will reduce the actuator hinge moment. Under some flight conditions, the available rudder will thus be limited by actuator force capability (aerodynamic blowdown). To study this effect, additional failure mode scenarios were evaluated with the reconstructed model. An actuator hinge moment less than the nominal value, applied as a failure mode to the model of the lower rudder, appeared to most closely match the rudder deflection trends as observed on the DFDR. In this failure mode condition, when full pedal is applied at $t=480$ s, the reconstructed lower rudder deflections appear to be consistent with the DFDR data (figure 69). It can be seen that the lower rudder is limited to about 3.2 degrees, while upper rudder is limited to 7 degrees. Analysis of the reconstructed flight data indicated that the lower rudder deflections appear to be primarily subjected to the effect of sideslip due to thrust application (figure 72). In particular, this can be seen at $t=590$ s when engine no. 1 and 2 thrust is reduced which causes the sideslip to decrease resulting into an increase of lower rudder authority. For the condition after the loss of flight control, analysis of the simulation model indicated that the increase of lower rudder deflection at $t=860$ s (figure 70) was primarily caused by a reduction of the aerodynamic blowdown effect on the lower rudder as the aircraft banks to the right. As a consequence, lower rudder authority is increased enabling the rudder to follow a combination of the commanded pedal and yaw damper commands due to yaw rate (figure 73). Reconstructed rudder surface deflections for this condition are indicated in figure 71 (lower rudder simulated with blowdown limit of 5.1 degrees).

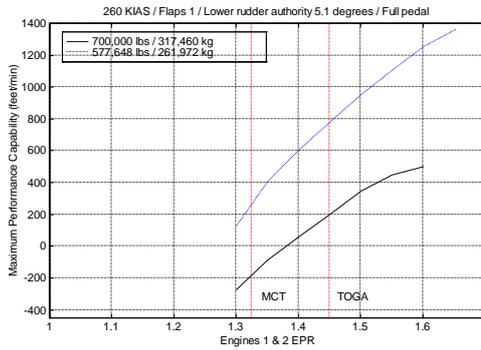
Fig. 74: Effect of engine thrust and weight on maximum climb performance for straight flight at 260 KTS

- The reconstructed model indicated that after separation of the engines from the aircraft, performance (figure 74) and controllability (figure 75) were degraded due to the heavy weight of the aircraft and additional drag of the damaged right wing. The relative large performance degradation at angles of attack greater than 8 degrees, at a load factor of 1.2 g, and at approximately 260 KIAS, could only be reconstructed by a significant increase of drag caused by the damaged wing. Application of thrust, combined with a delayed pedal input, resulted into a loss of flight control.

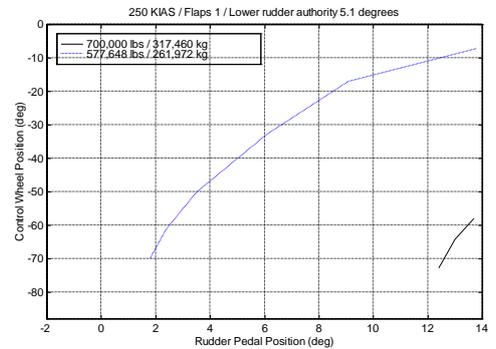
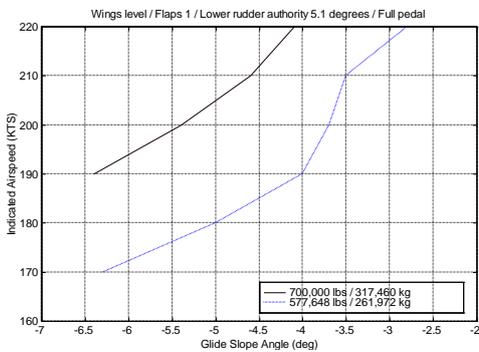
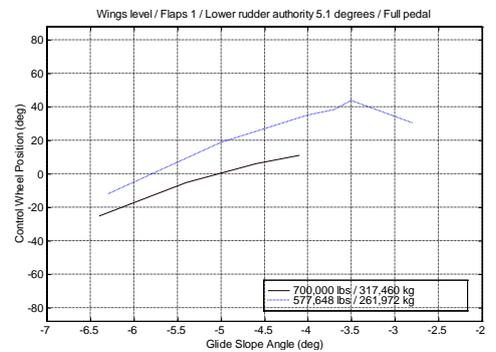
Fig. 77: Effect of weight on lateral control for straight and level flight at 250 KTS

Fig. 78: Effect of weight on indicated airspeeds and attainable flight path angles for simulated low-drag approach profile

Fig. 79: Effect of weight on lateral control and attainable flight path angles for simulated low-drag approach profile

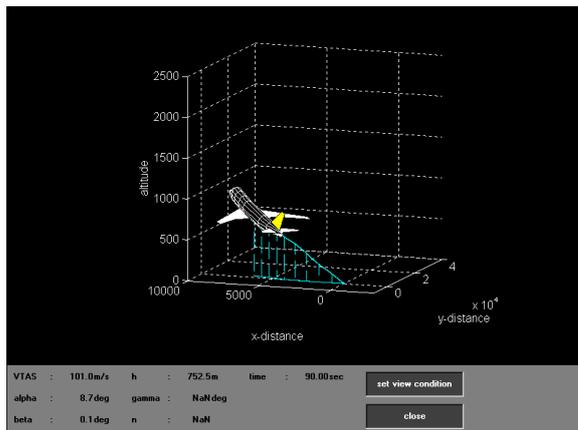
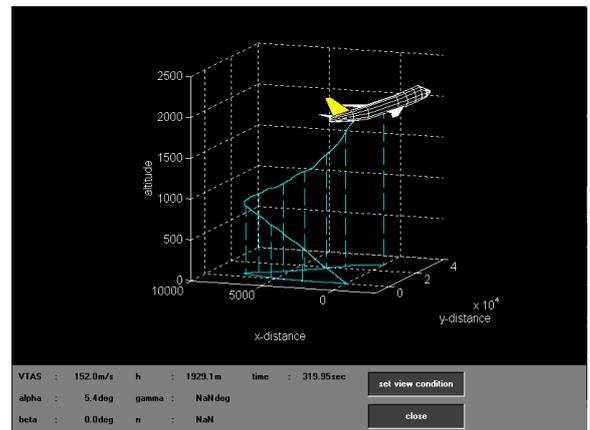
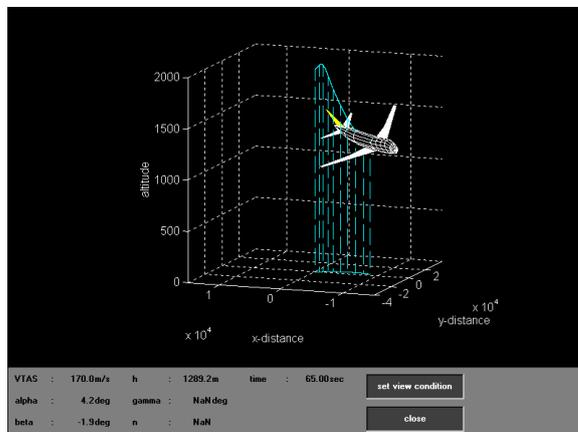
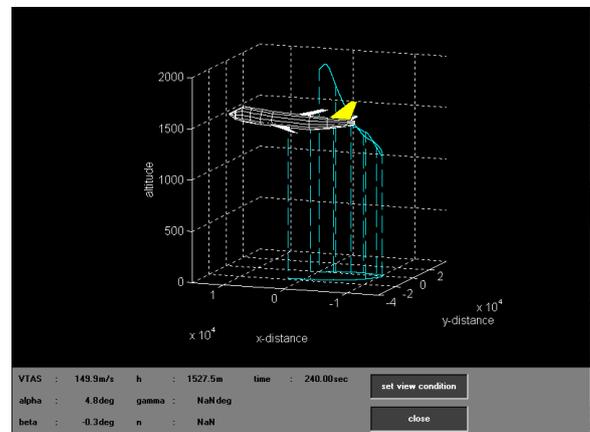
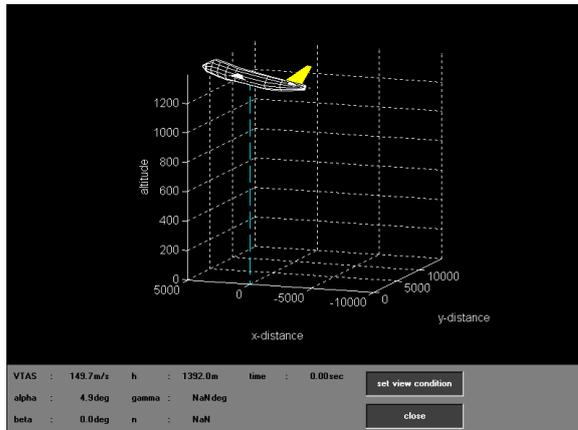
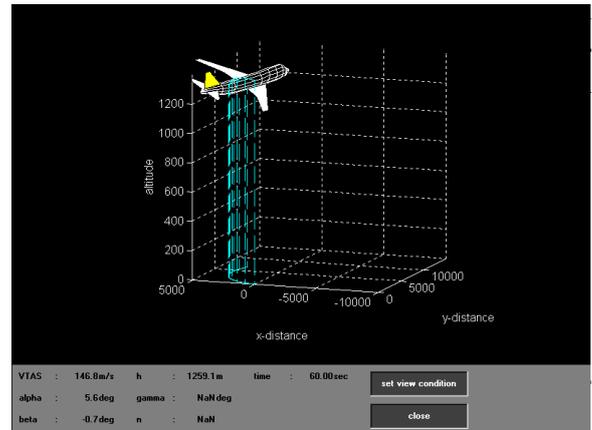
The figures on the following pages demonstrate the 3D-visualisation capabilities of the analysis software as used for reconstruction of the accident flight. A 3D profile of the reconstructed flight from takeoff up to the final stage of flight is illustrated in the figures a-k. Figures l-o show a 3D visualisation of a control loss recovery strategy applied to the reconstructed model. Simulation was performed using the on-line analysis capabilities of the simulation environment.
